Exterior Asbestos and Lead Paint Survey Report for Repainting

Buchanan High School
1560 N. Minnewawa Avenue
Clovis, CA 93619

FACS Project #PJ15618

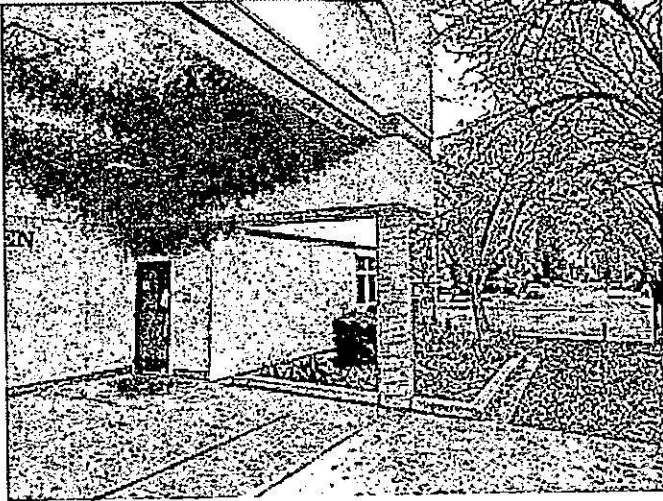
Blue Paint on Metal Wall Trim

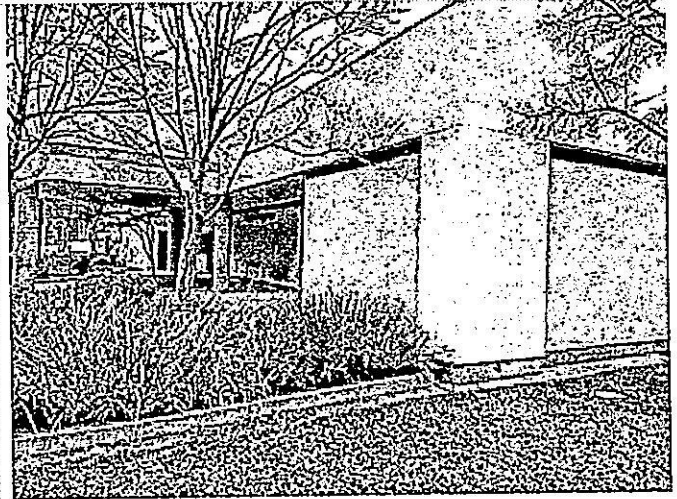
White Paint on Stucco Walls

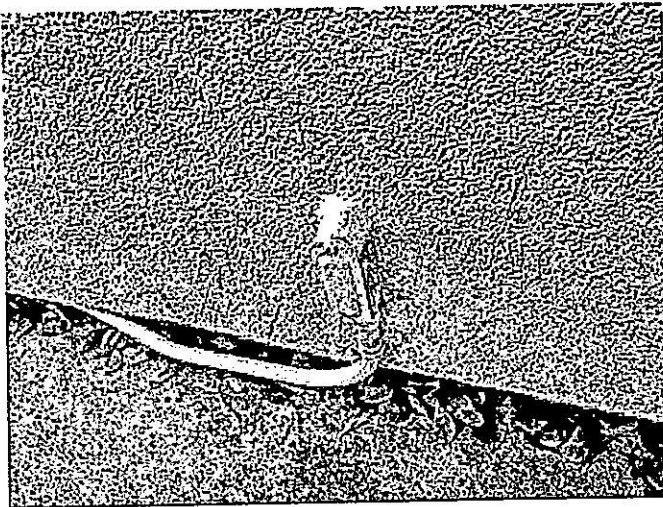
Lead Containing Paint on Metal Conduit Line

Workers that impact paints containing any detectable amount of lead must use lead-safe practices and have valid training for the method of impact to comply with Cal/OSHA, 8 CCR 1532.1. To comply with CDPH requirements, any disturbance to paints or coatings that contain lead must be completed within a contained area to prevent the creation of a lead hazard. To comply with California Department of Toxic Substance Control and Title 22 requirements, any waste streams containing lead must be profiled prior to disposal.

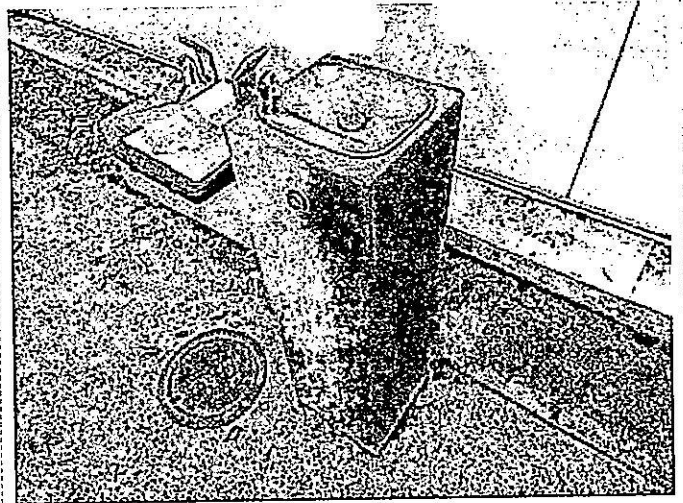
Lead Containing Paint on Metal Drinking Fountain
